This schematic is a segment of the SR-150 "A" level radio

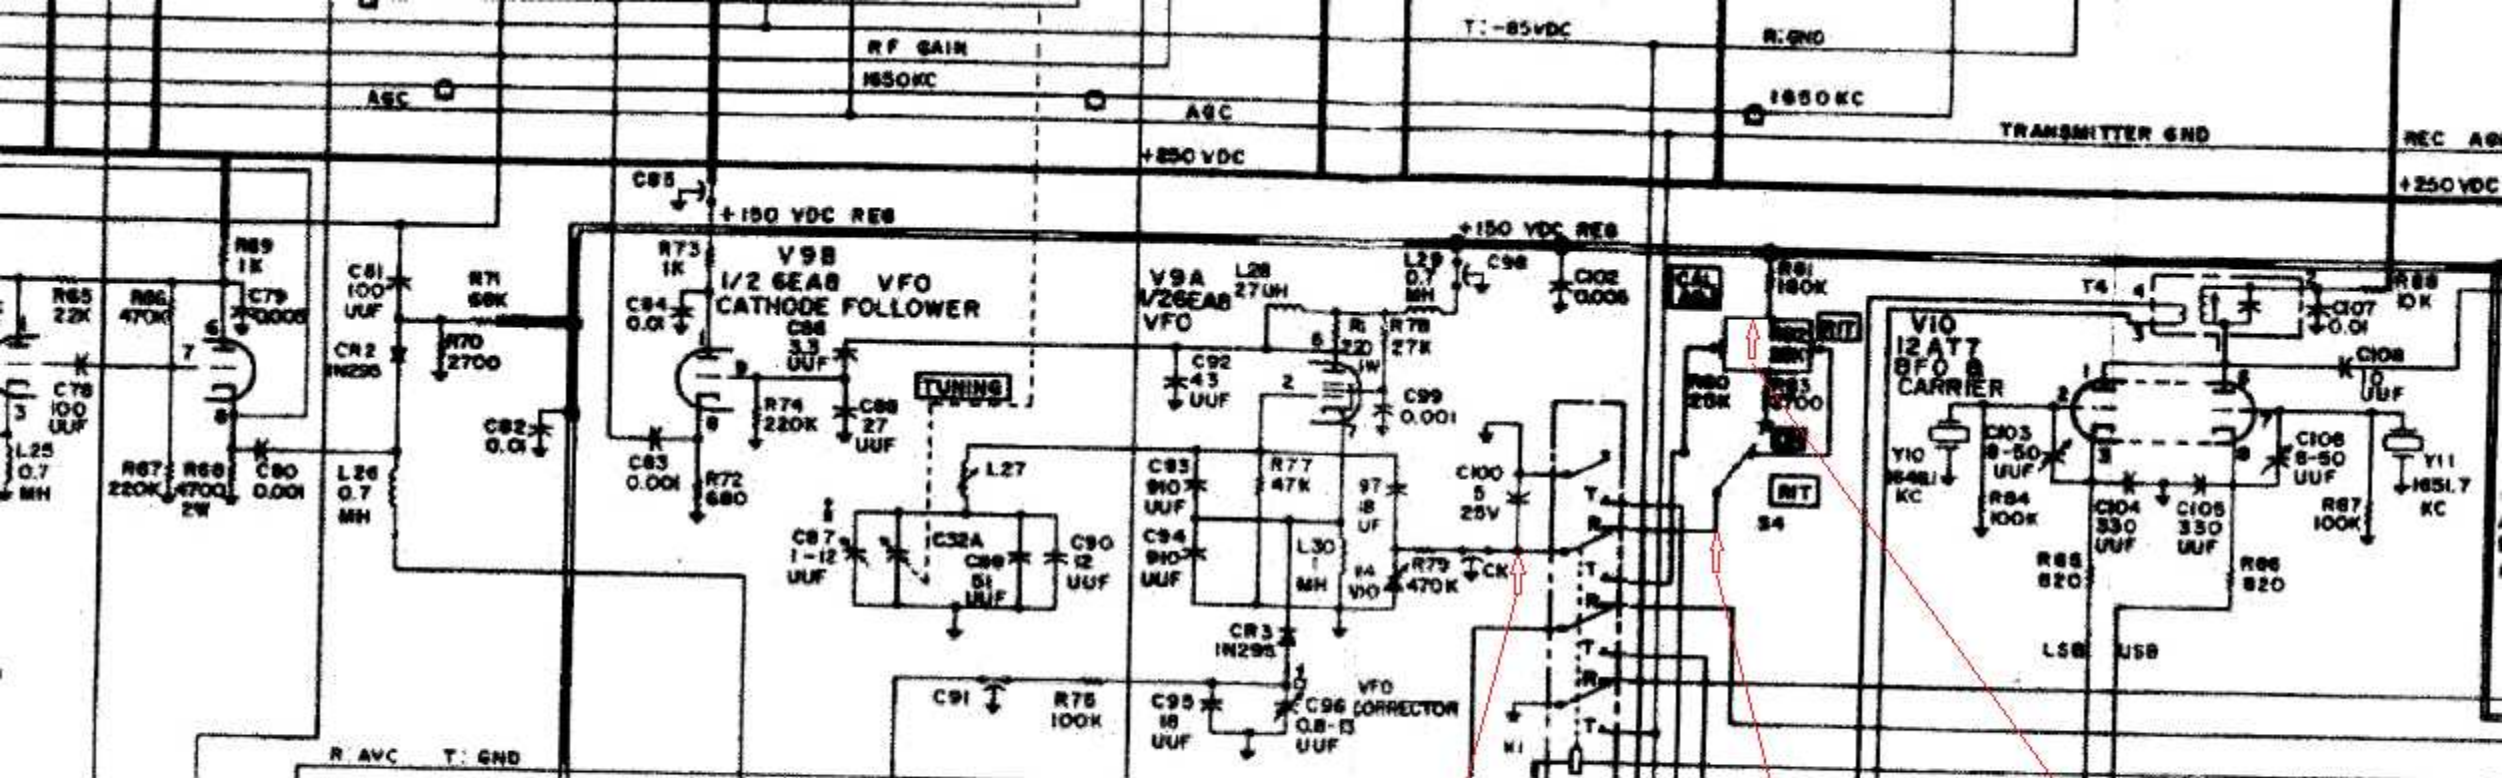
This 5uf capacitor was installed to correct the 60 cycle sidebands in the VFO. The location was not well thought out. Although it corrects the 60 cycle problem, it causes a chirp in the transmit and receive signals.

The chirp only occurs when the RIT function is enabled and is worse as the RIT frequency deviates from the fixed frequency. It is caused by the varying voltage on the varactor diode as the capacitor charges. It will charge or discharge depending where the RIT frequency is set when transitioning from XMIT to receive or receive to XMIT.

Later level radios moved it here but it did nothing for the 60 cycle distortion.

If you move the capacitor from where it is to the other side of the relay the chirp will only occur when you are in receive mode and when you flip the RIT switch. This is not a problem.

Move it from here.

To here  
If it's not at either location add it here
