Corrects FMING problem
Will not cause chirp

K9AXN
03/18/2014

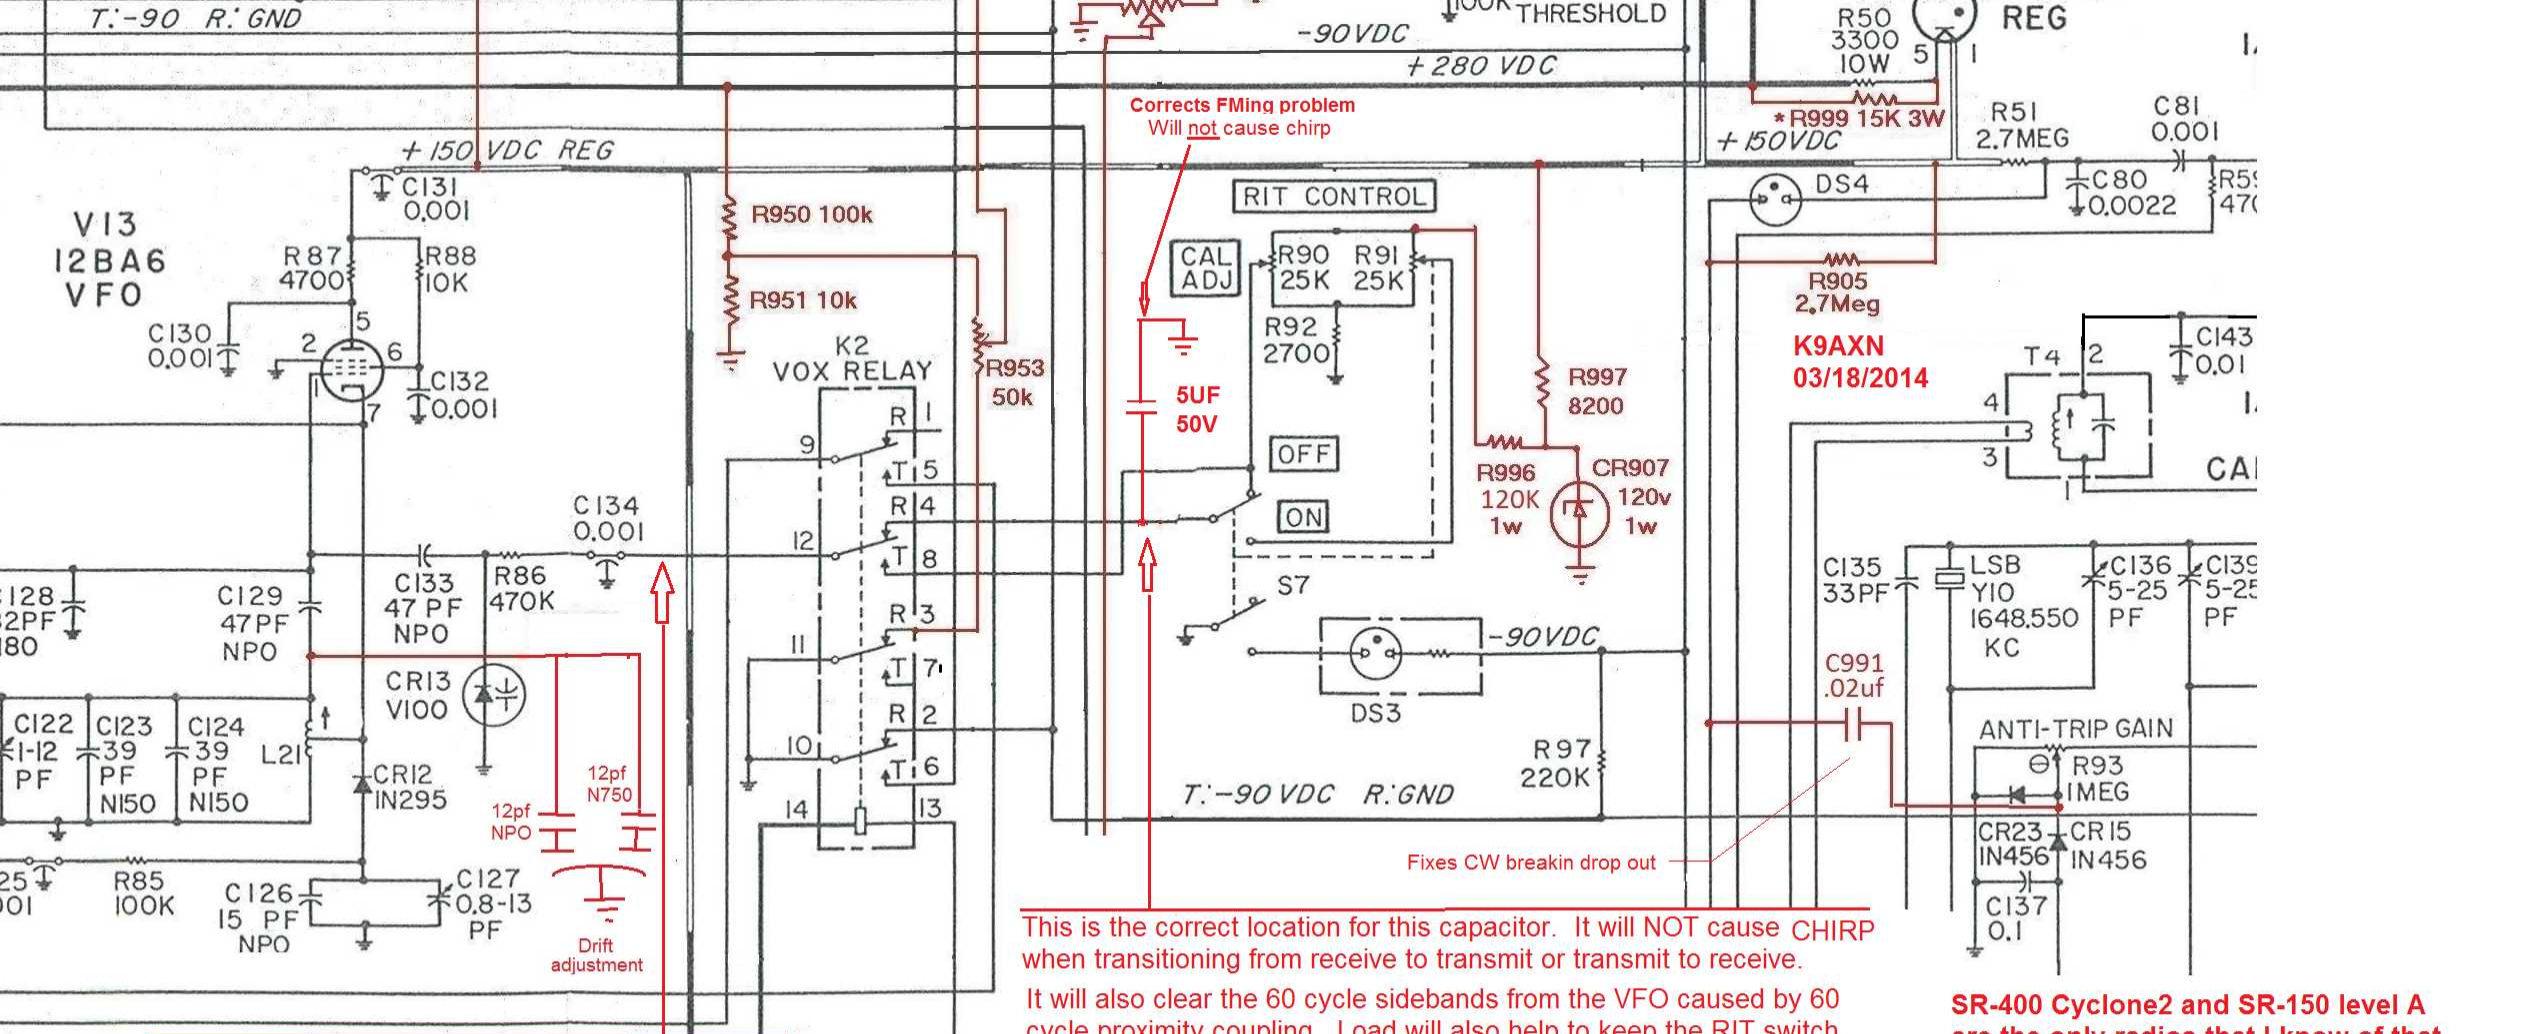
This is the correct location for this capacitor. It will NOT cause CHIRP when transitioning from receive to transmit or transmit to receive.

It will also clear the 60 cycle sidebands from the VFO caused by 60 cycle proximity coupling. Load will also help to keep the RIT switch clean.

Audio will be significantly enhanced

The capacitor was originally used in the SR-150 and later in the Cyclone 2 but was placed here causing CHIRP when transitioning from receive to transmit and transmit to receive.

SR-400 Cyclone2 and SR-150 level A are the only radios that I know of that still have the capacitor in the wrong place

Fixes CW breakin drop out

Install this capacitor on all SR-150, SR-400, SR400A, and SR-2000 radios
